FACILITY STATUS CHANGE FORM (for DOE/RL-2010-34 Facilities)

Date Submitted: February 3, 2014 Originator: Clay McCurley Phone: 942-8928	Area: 100D Facility ID: 151D Primary Electrical Substation Action Memorandum: General Hanford Site Decommissioning Activities	Control #: D4-100D-003-1
--	---	------------------------------------

Photographs of the 151D Primary Electrical Substation (3 pages)

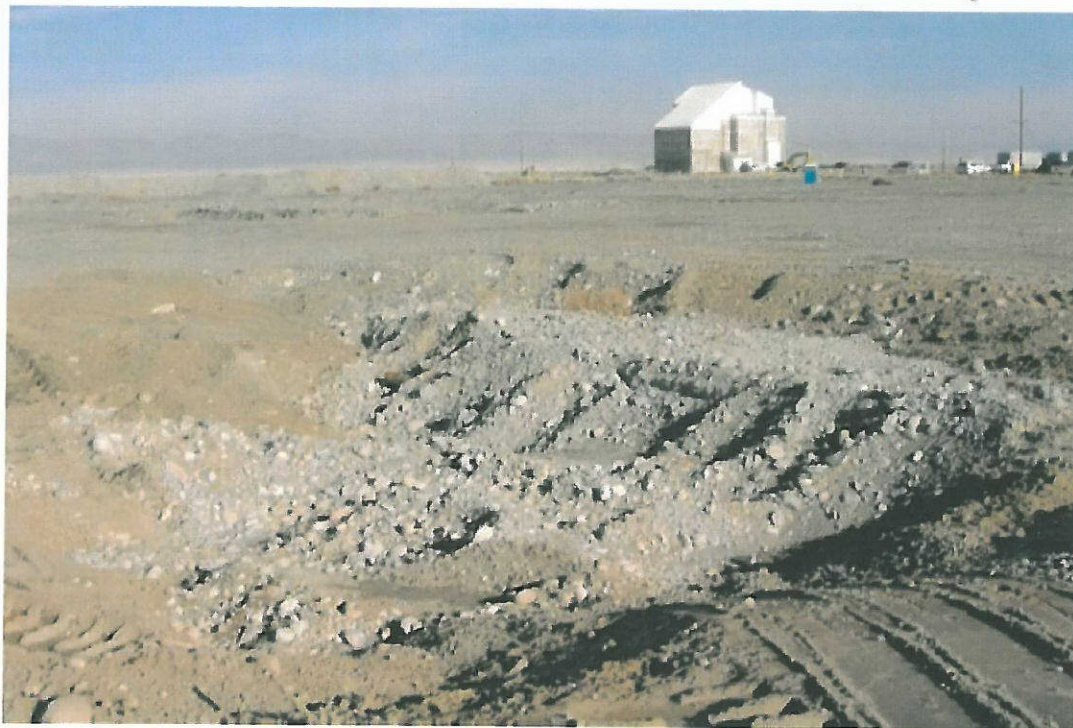
Photo 1. Backfill material over below-grade vault near southwest corner of yard.

Mark. I conducted a visual inspection of the 151-D switch yard earlier this month. This email documents my findings. I did not observe any anomalies. Attached are photographs I took of the switch yard while I was there. We left two concrete vaults (located between the primary substation building and the oil circuit breaker (OCB) pads on the south end of the switch yard) which were greater-than 3-feet below-grade. Backfill material was placed in the larger excavated hole to eliminate safety concerns associated with steepened edges (see Photo 1 in attachment 2). The rest of the area was slightly wet (from heavy morning dew) which made it difficult to determine if soil discoloration was due to oil or water. The two ground stains, visible in historical aerial photos along the railroad spur, were not obvious although I did observe some discoloration in that area that could have been one of the stains. A review of recent aerial photos shows the stains were covered during or soon after completing demolition of the 151-D primary substation building in April, 2013. The rest of the area appears clean.

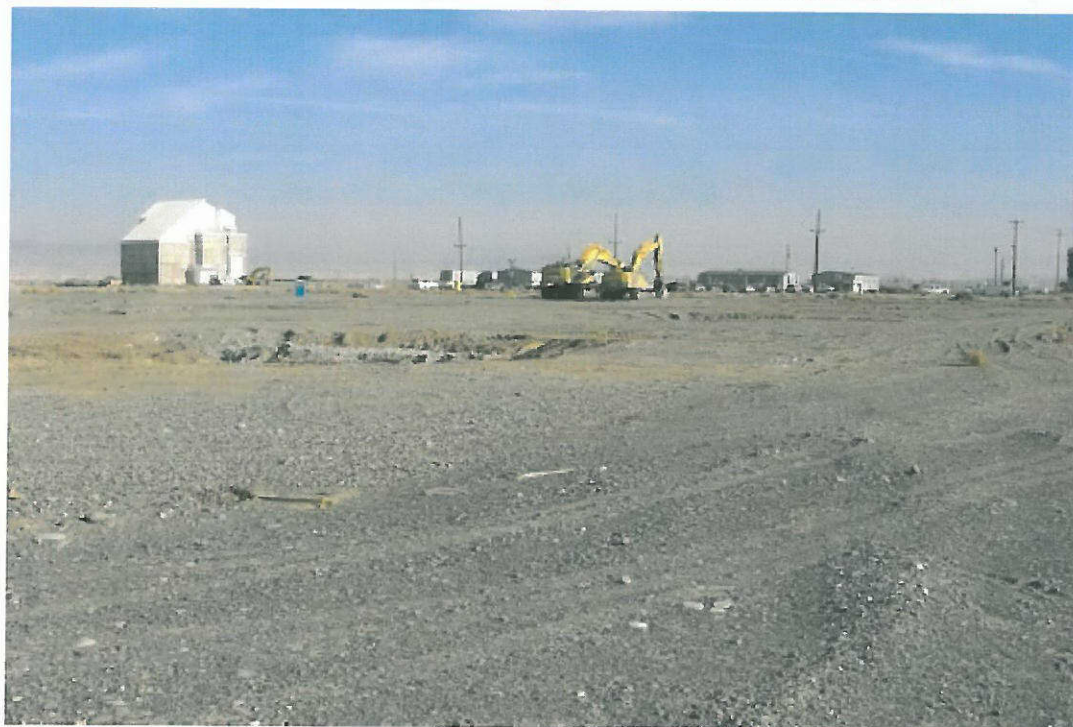
Photo 2. Former switch yard facing northeast from southwest corner

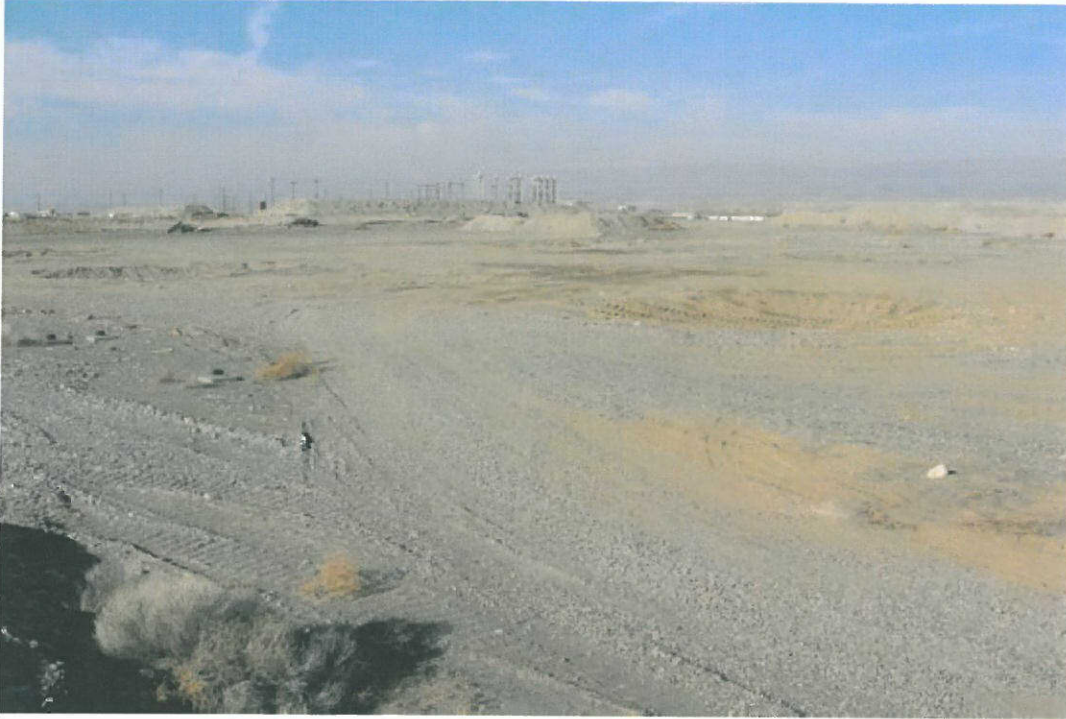
Photo 3. Former switch yard facing northwest from southeast corner.
